The root cause of a shaft crack

by **Don Silcock**
Bentley Nevada Corporation

Shaft crack shuts down plant

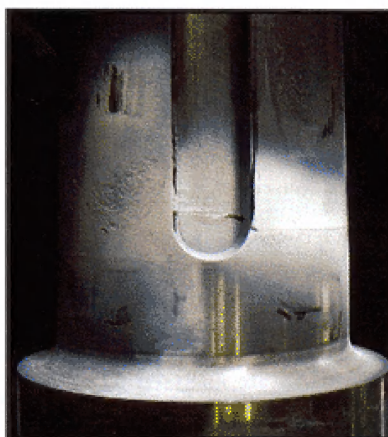
In October 1991, information from an online Bentley Nevada Dynamic Data Manager® System suggested that a crack might be propagating on the input shaft of the speed increasing gearbox. Maintenance personnel advised that the syn gas compressor be shut down immediately, which stopped the ammonia plant and downstream production. Upon disassembly, maintenance technicians found that the input shaft coupling taper was cracked, 180 degrees around its circumference and through 55% of its diameter (see photo pg.21).

Incitec commissioned a failure analysis of the input shaft that included fractography, chemical analysis, metallurgical examination and hardness testing. Fractographic analysis of the damaged shaft showed that the crack had begun adjacent to the coupling taper keyway, where fretting and corrosion damage was evident. The crack had slowly spread, radially and against the direction of rotation, into the coupling taper keyway. Then, it reversed direction and spread rapidly in the direction of rotation. Failure analysis concluded that the shaft cracked due to fatigue.

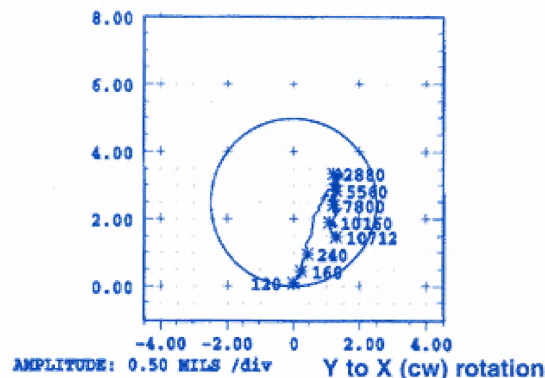
Figure 3

Obviously, the reaction turbine, gearbox and LP compressor had not been correctly aligned. This was clearly shown in TDM2 average shaft centerline position plots, of the gearbox "northwest" bearing and the LP compressor drive-end bearing.

In a machine with fluid-film bearings, such as this, the rotor normally rises on an oil wedge as it gains speed. At operating speed, a shaft rotating Y to X (cw) with no abnormal load will usually be in the lower left quadrant of its bearing. It is clear from Figures 3 and 4 that the rotor is abnormally loaded, because of the atypical operating positions.

Shaft centerline plot, showing movement of the gearbox high speed pinion in the "northwest bearing" during machine startup.

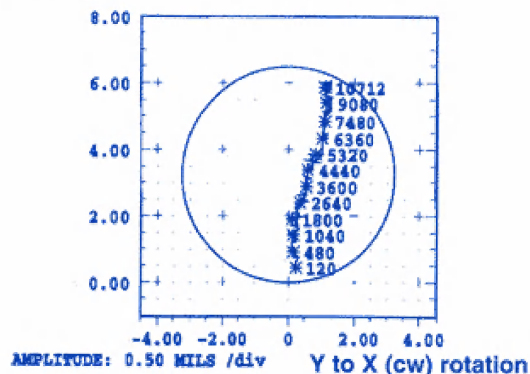
Figure 4

Shaft centerline plot, showing the shaft movement at the drive end bearing of the LP compressor during machine startup.
